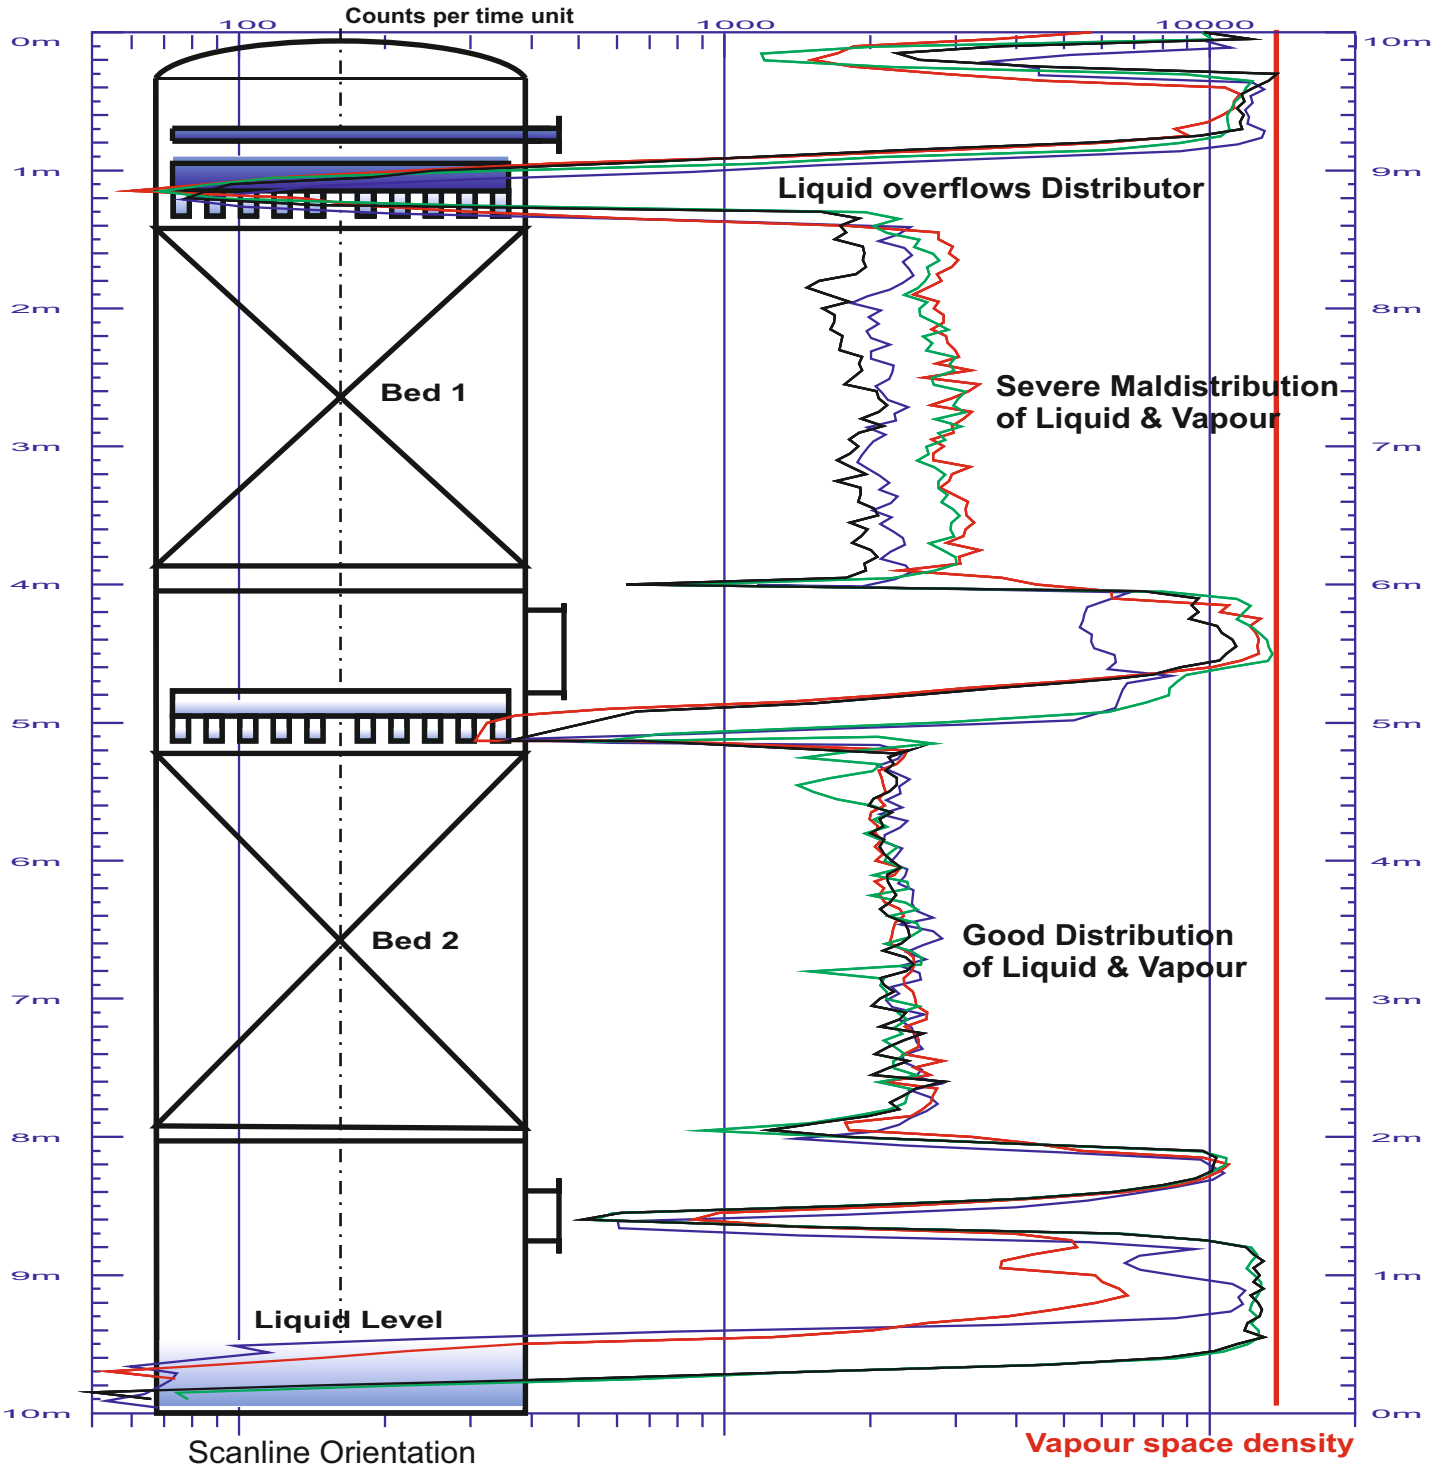
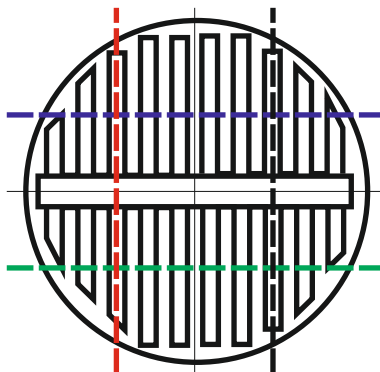
Both liquid distributors have same design / construction. Distributor of bed 1 is overflowing and generates severe maldistribution of liquid / vapour in the bed. The drip holes were partially plugged due to debris in the reflux pipe during start up.

Distributor of bed 2 is working proper. It is possible to measure the liquid levels in parting box and distribution troughs. The distribution of phases is quite good across cross section and height of bed 2.
