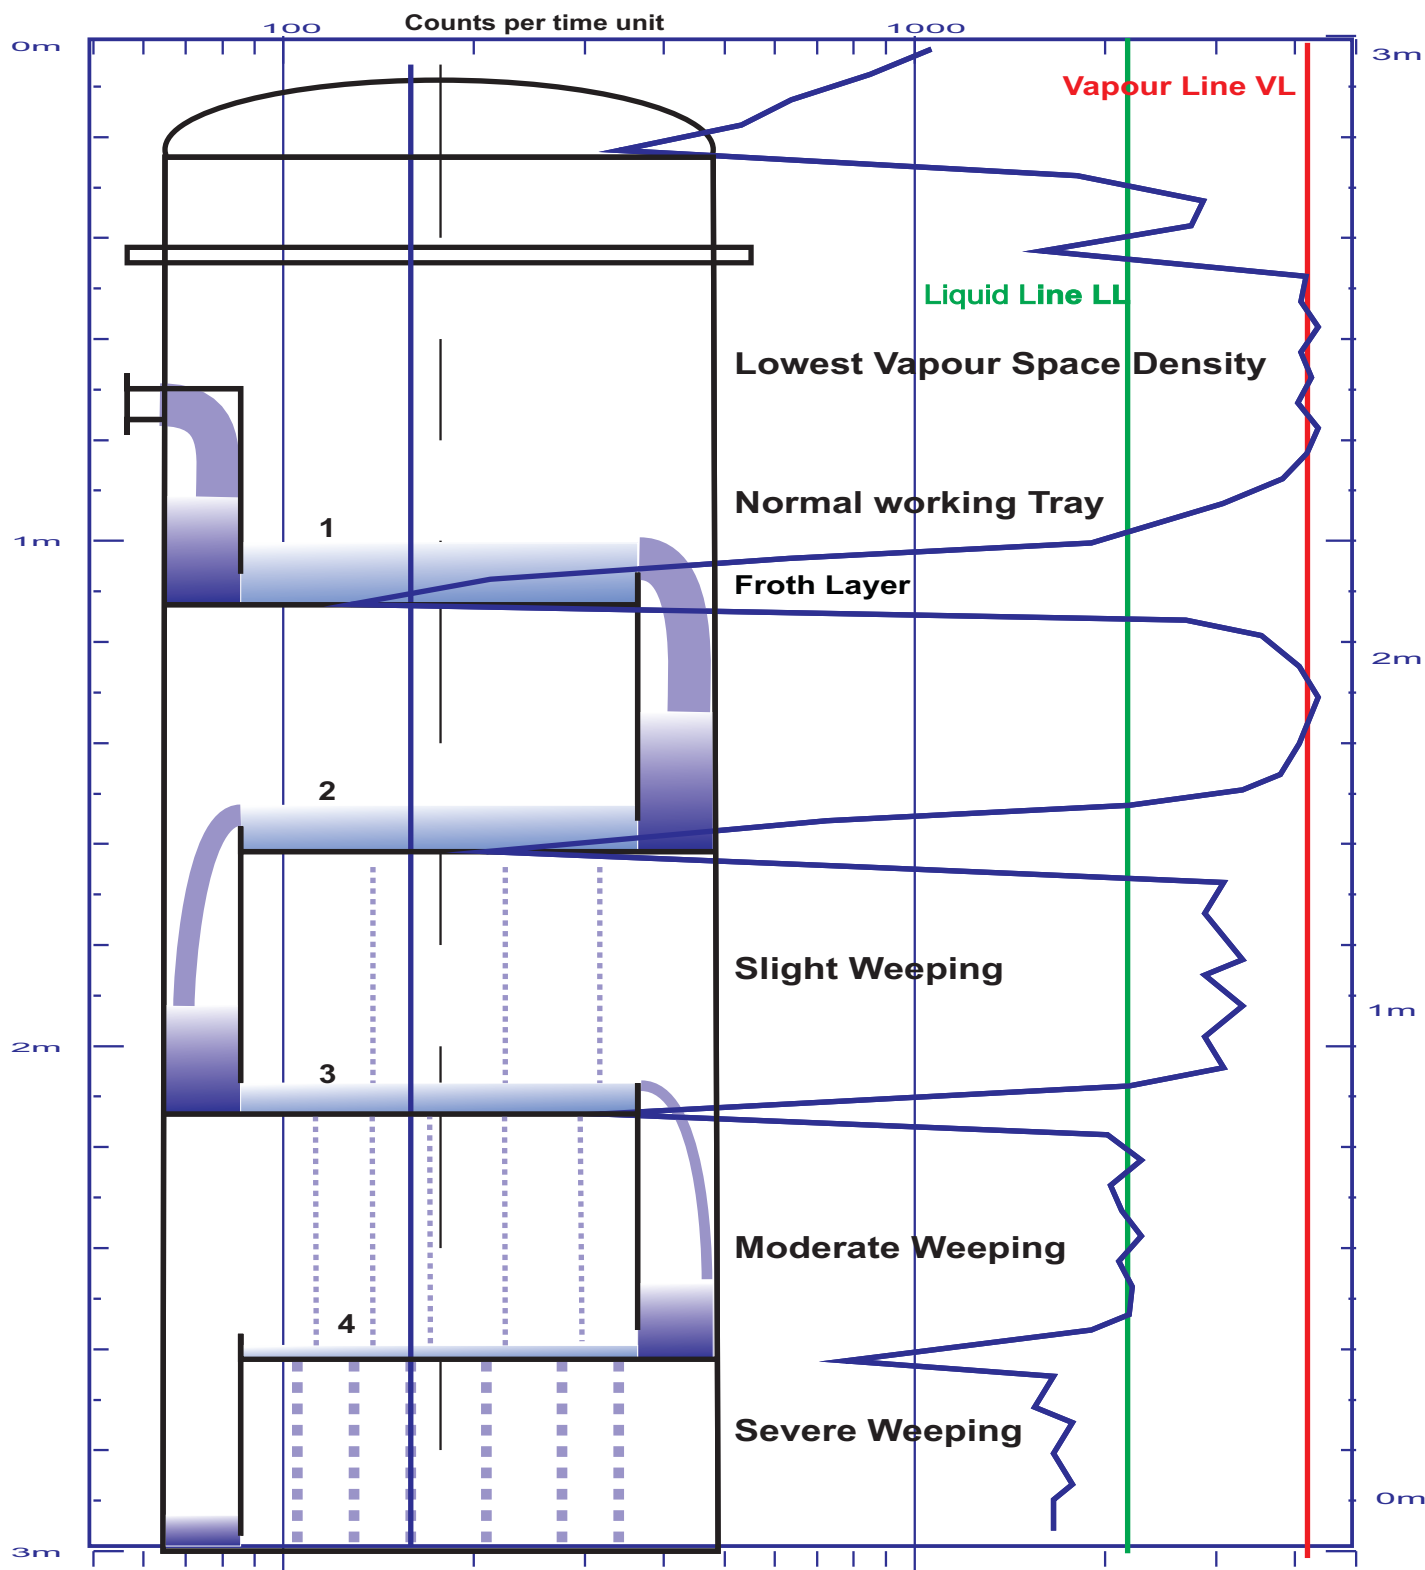
The weeping rate depends on vapour velocity, vapour cross flow area, liquid rate / weir height, tray type, seal of tray section overlap and manufacturing quality of trays.

Possible reasons for weeping:

- Vapour cross flow area too large selected
- Vapour cross flow area was increased due to corrosion / erosion
- Valves / bubble caps were removed / lost
- Tray section overlap is not seal due to loose bolting or deformation
