I B E Ingenieurbüro Esper GmbH  
Verfahrenstechnik, Kolonnen- & Prozessdiagnostik

### Scan of a distillation tower in a Refinery

### Scan of a distillation column for Toluene in an aromatic plant

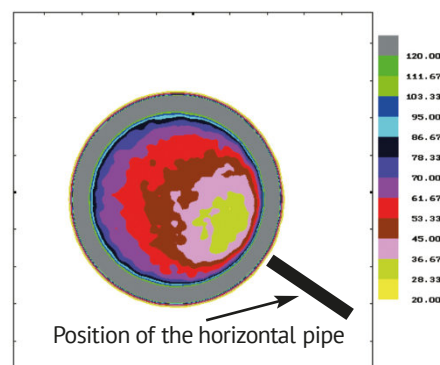
Ratio of the mixture:  
HC : Nm<sup>3</sup>H<sub>2</sub>=1 :5  
Result: **Maldistribution** of H<sub>2</sub>  
at the inside elbow-side of  
the feed pipe
